NATIONAL PROGRAM FOR INSPECTION OF NON-FEDERAL DAMS  
GOODWIN DAM (CT 00541 (U) CORPS OF ENGINEERS WALTHAM  
MA NEW ENGLAND DIV SEP 78

FARMINGTON, CONNECTICUT

# GOODWIN DAM CT. 06541

## PHASE 1 INSPECTION REPORT DAM INSPECTION PROGRAM

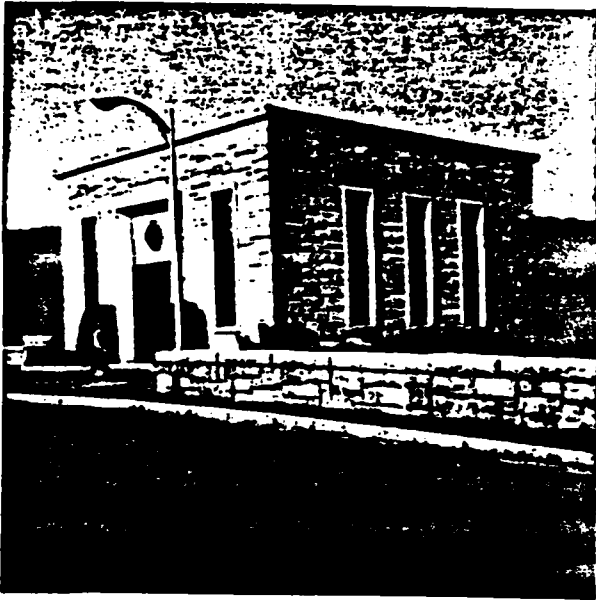
#4. Upper Gate House is in excellent condition.

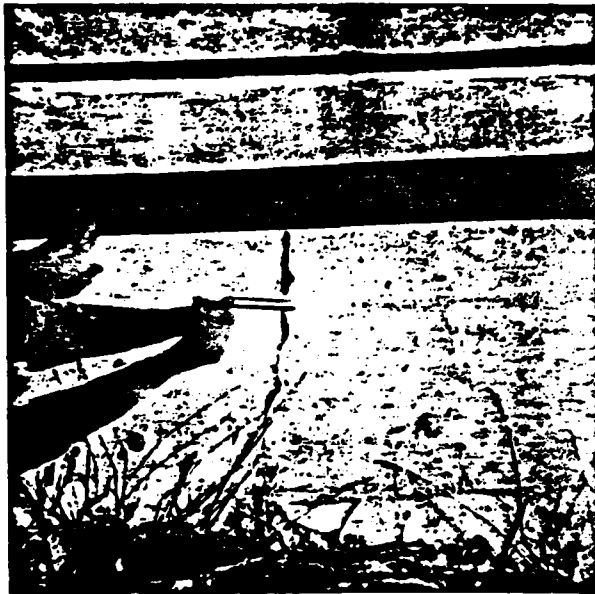
#11. South face at West end. Finger points to location of rollers.
